A D V A N C E D IMAGING

July/August 2005
A Cygnus Publication

Shuttle's Imaging Network Captures Falling Debris

NASA's shuttle program grounded after electronic imaging discovers 'debris event.'

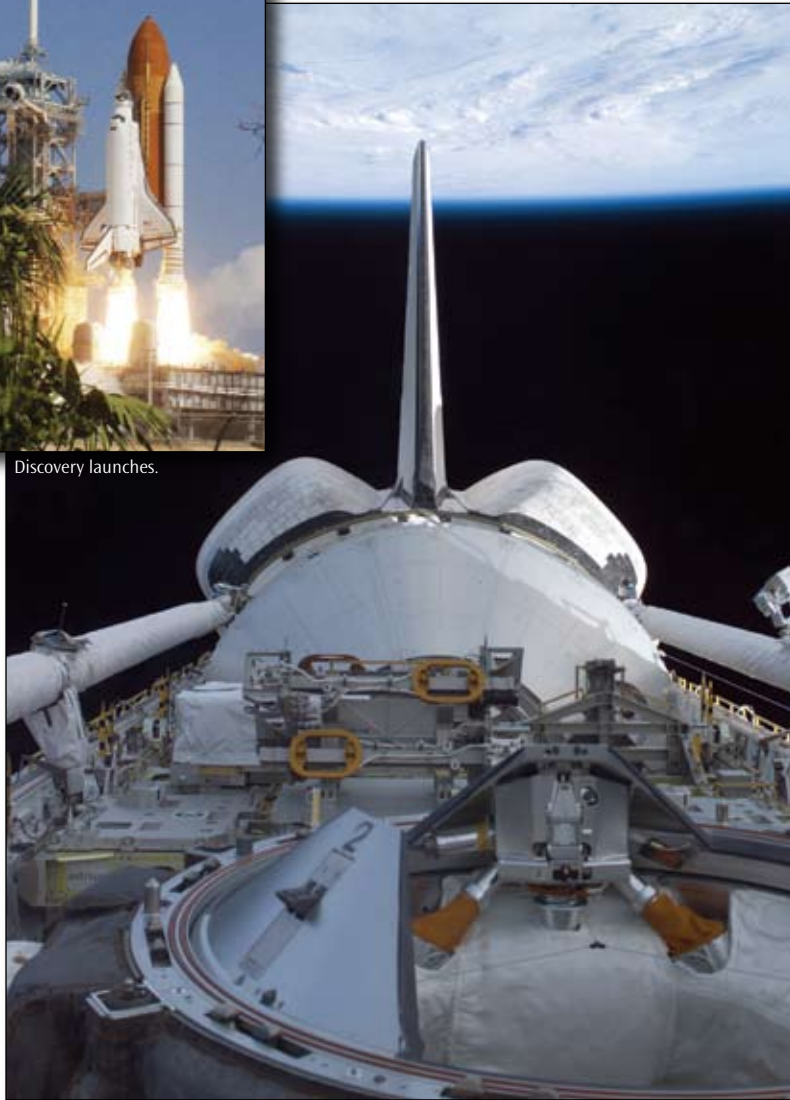
Discovery's cargo bay over Earth's horizon was photographed by one of the seven STS-114 crew members as the astronauts move within 24 hours of docking with the International Space Station. Photo: NASA
